## ENERGY EFFICIENT ENGINE

### HIGH PRESSURE TURBINE THERMAL BARRIER COATING SUPPORT TECHNOLOGY REPORT

E.C. Duderstadt and P. Agarwal

GENERAL ELECTRIC COMPANY

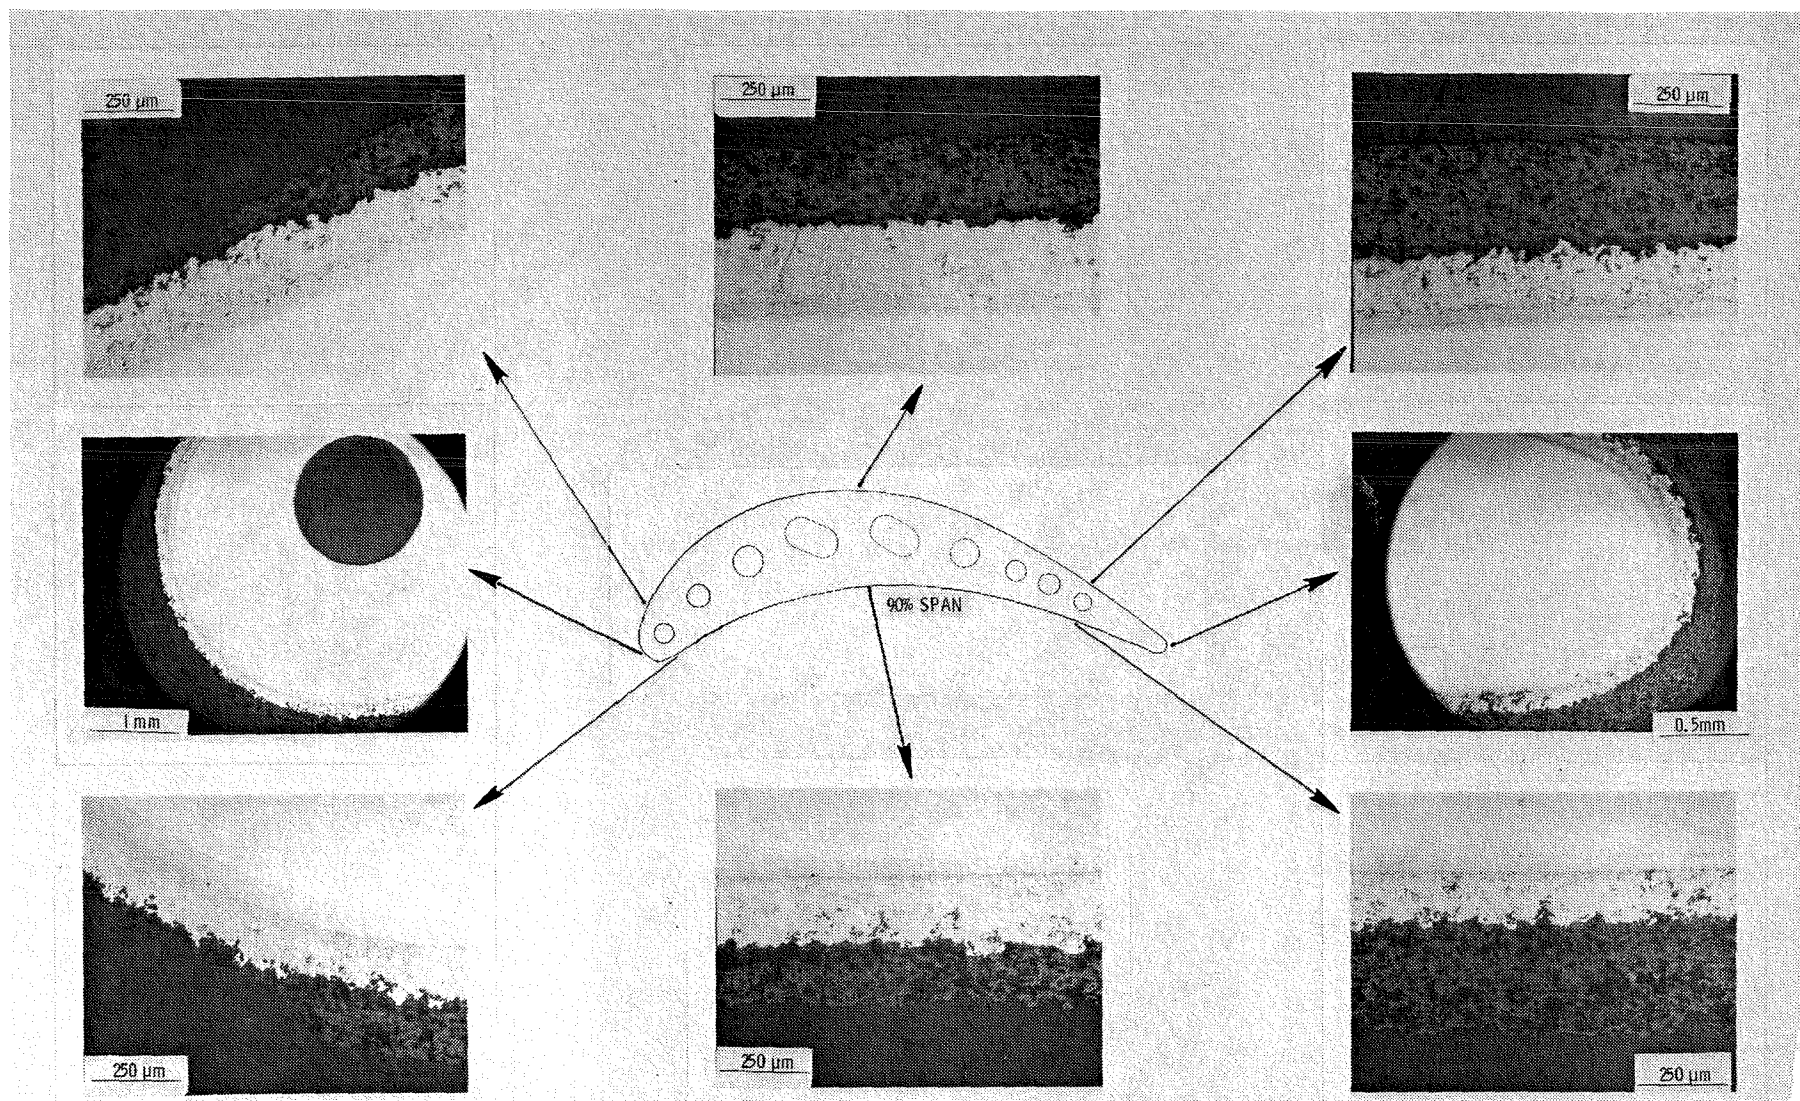
Three of the engine-tested thermal-barrier-coated blades, one with each type of ceramic layer and one blade without TBC (Codep only), were sectioned at 40%, 70%, and 90% span and in the platform region and prepared for metallographic examination. Microstructural examination showed the thermal barrier coatings on all three blades to be in excellent condition in all areas except at the leading edge of the suction side where the ceramic layer had been damaged. The blade with Codep coating only showed normal microstructure without any damage.

Figure 51a. Photomicrographs of Engine-Tested (1000 "C" Cycles) CF6-50 Stage 2 Blade With TBC (Ni-22Cr-10Al-1Y/ZrO<sub>2</sub>-8%Y<sub>2</sub>O<sub>3</sub> Duplex), 90% Span (Blade No. 39, Table XV).

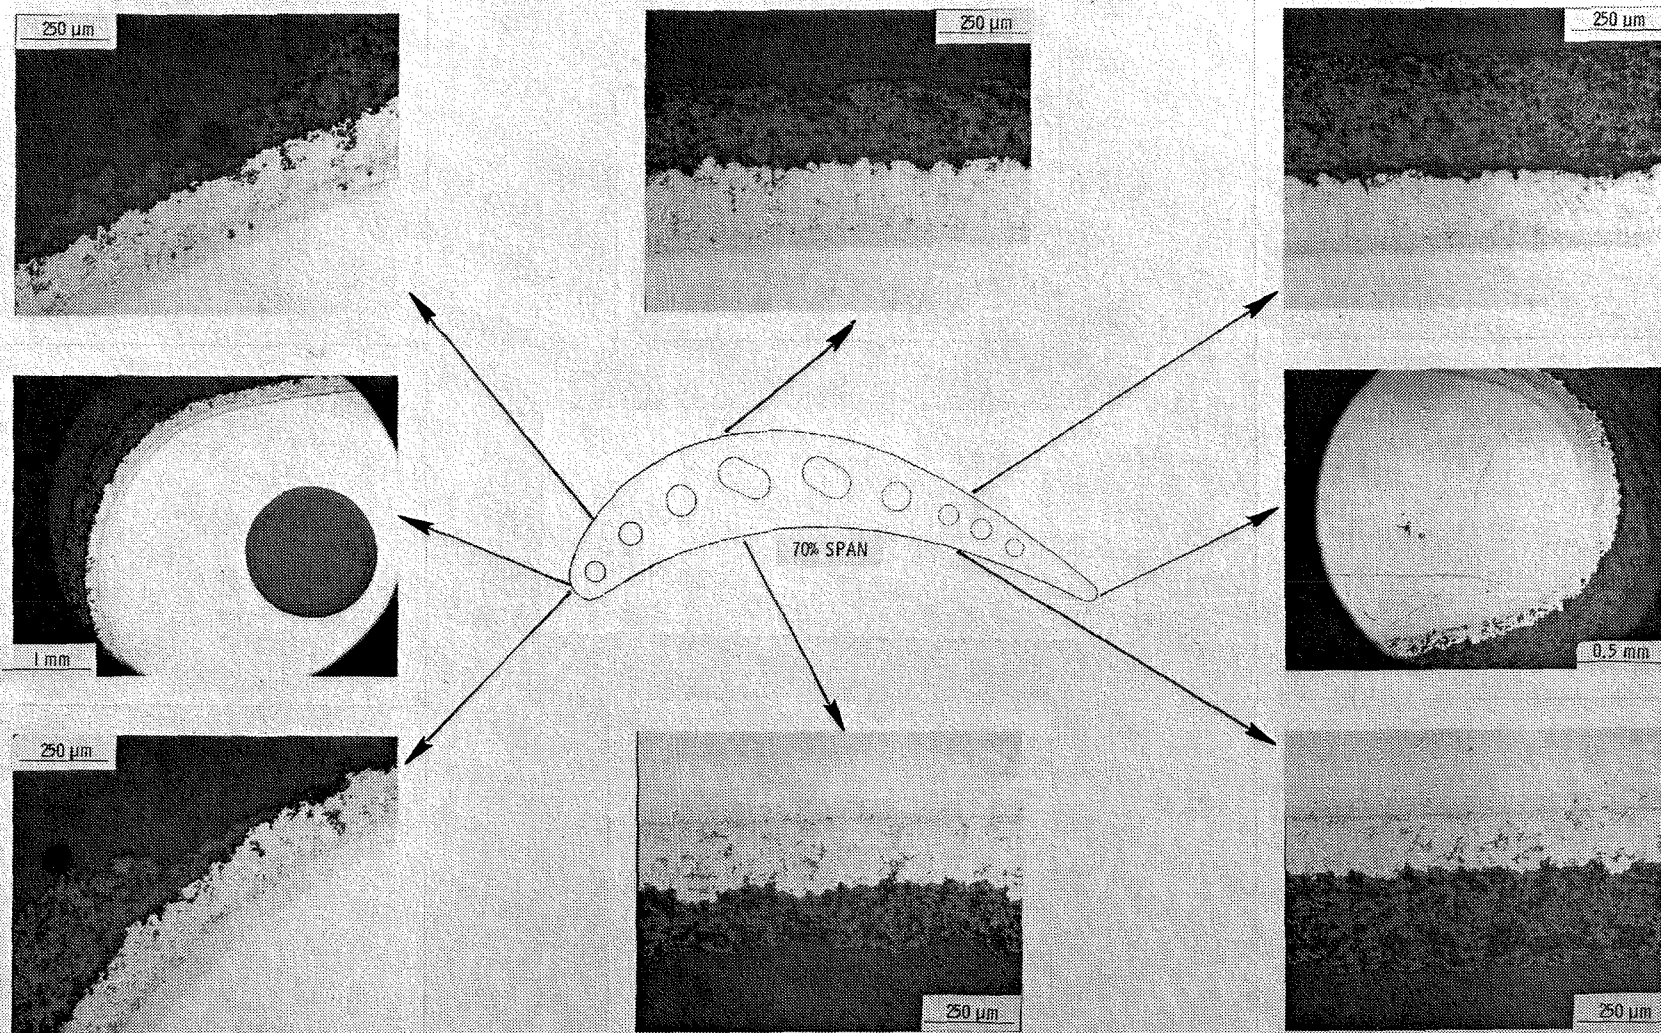
Figure 51b. Photomicrographs of Engine-Tested (1000 "C" Cycles) CF6-50 Stage 2 Blade With TBC (Ni-22Cr-10Al-1Y/ZrO<sub>2</sub>-8%Y<sub>2</sub>O<sub>3</sub> Duplex), 70% Span (Blade No. 39, Table XV).

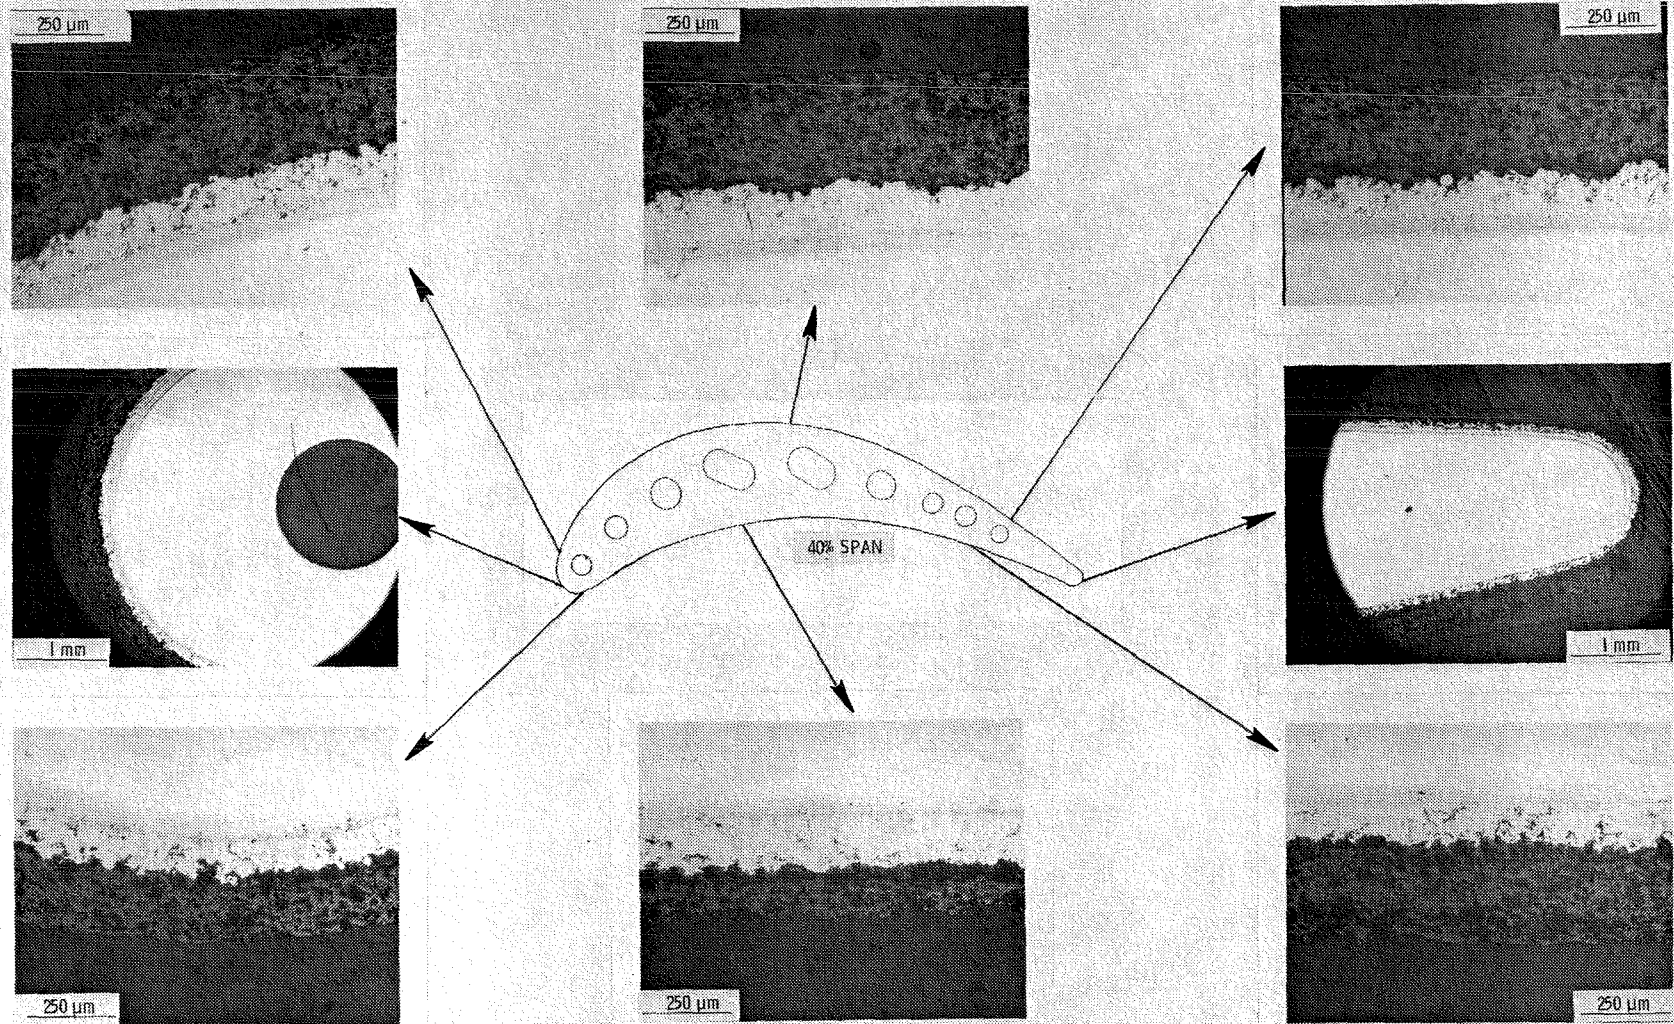
Figure 51c. Photomicrographs of Engine-Tested (1000 "C" Cycles) CF6-50 Stage 2 Blade With TBC (Ni-22Cr-10Al-1Y/ZrO<sub>2</sub>-8%Y<sub>2</sub>O<sub>3</sub> Duplex), 40% Span (Blade No. 39, Table XV).

followed by the Ni-Cr-Al-Y bond coat and the  $\text{ZrO}_2\text{-Y}_2\text{O}_3$  ceramic top coat. The bond coat is intimately bonded to the Codep layer. The microstructure, porosity, and thickness uniformity are typical of VPS applied bond coats on Blades 39 and 41, but the structure of the coating on Blade 42 is, for some reason, unusually porous and nonuniform for low pressure, plasma-sprayed bond coats. There was no loss or separation of the bond coat from the airfoil surface, including areas where the ceramic layer was damaged. Very little, if any, bond coat oxidation was observed on any of the blades. The ceramic layer on all three blades also appeared to be in excellent condition over most of the airfoil surface with the exception of the leading edge on the suction side where impact damage had occurred. The ceramic layer is adherent to the bond coat and shows no evidence of cracking or separation. Its microstructure is typical of conventionally plasma-sprayed ceramic coatings. Overall, the thermal barrier coatings on all three blades appear in sound condition microstructurally.

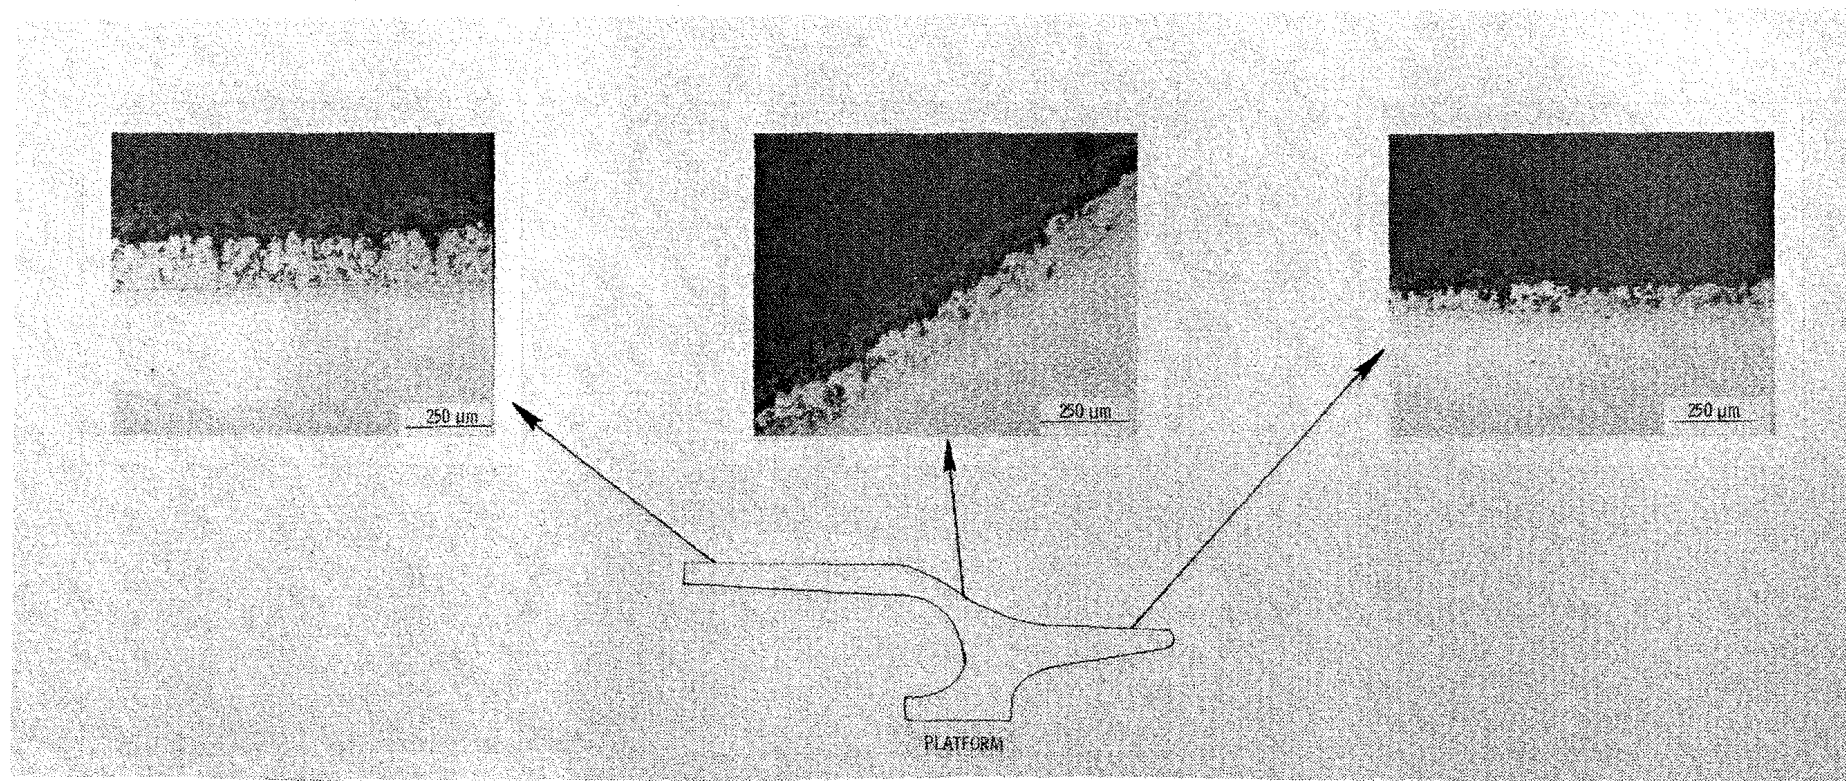
Figure 5ld. Photomicrographs of Engine-Tested (1000 "C" Cycles) CF6-50 Stage 2 Blade With TBC (Ni-22Cr-10Al-1Y/ZrO<sub>2</sub>-8%Y<sub>2</sub>O<sub>3</sub> Duplex), Platform (Blade No. 39, Table XV).

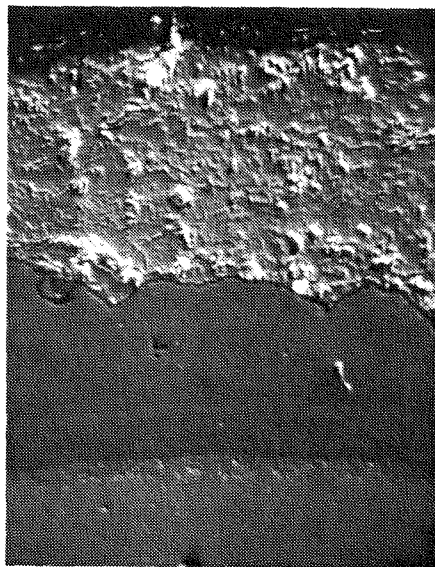
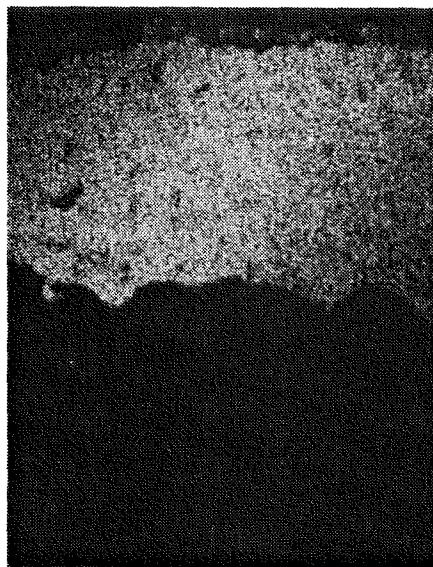
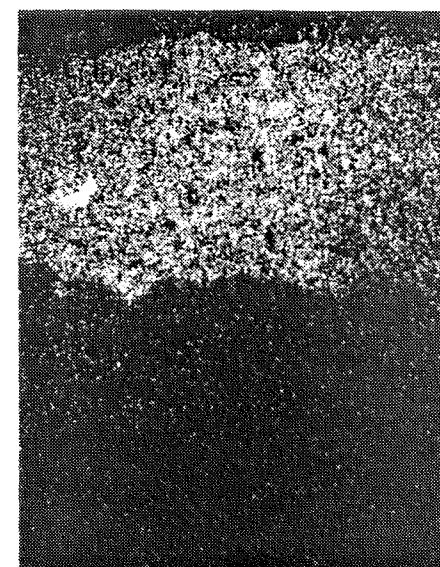
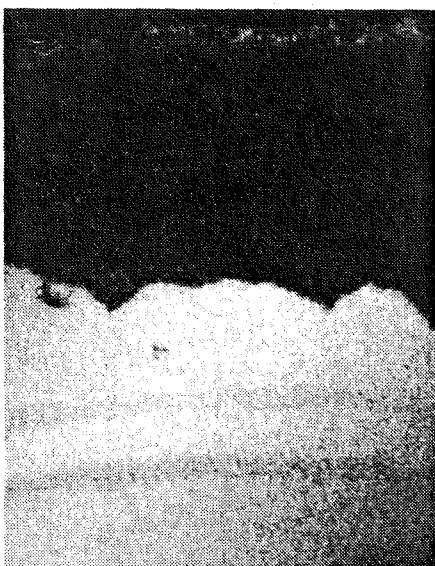
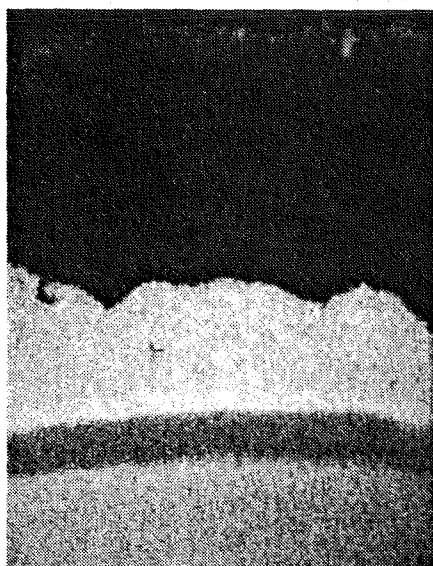
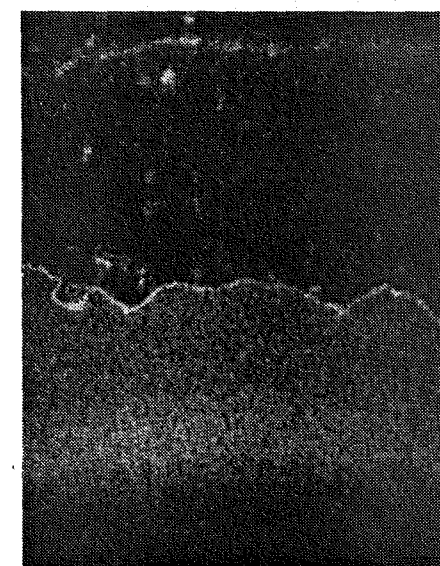
Electron microprobe analysis was performed at the 80% span to examine for interaction and interdiffusion between the TBC and the substrate. Figures 52 through 54 show the secondary electron images and X-ray density maps of Ni, Cr, Al, Zr, and Y for the three blades. It can be observed that no interaction or extensive interdiffusion occurred between the ceramic layer and the metallic bond coat layer. A thin scale (4-5  $\mu\text{m}$ ) of  $\text{Al}_2\text{O}_3$  is present at the top coat/bond coat interface, which is normal, but there was no further oxidation of the bond coat. Interdiffusion between the bond coat and Codep layer and the Codep layer and René 80 substrate was minimal as indicated by the uniform distribution of the bond coat elements Ni, Cr, and Al. This may be attributed to the presence of the Codep layer between the bond coat and René 80 and to bond coat temperatures not exceeding 1255 K (1800° F) in most areas of the blade.

Figure 52. Secondary Electron Image and Elemental X-Ray Density Maps of Engine-Tested Stage 2 Blade (René 80) With Codep, Vacuum Plasma Sprayed Ni-22Cr-10Al-1Y and  $\text{ZrO}_2$ -20% $\text{Y}_2\text{O}_3$  Coatings - Leading Edge, Suction Side at 80% Span (Blade No. 41, Table XV).

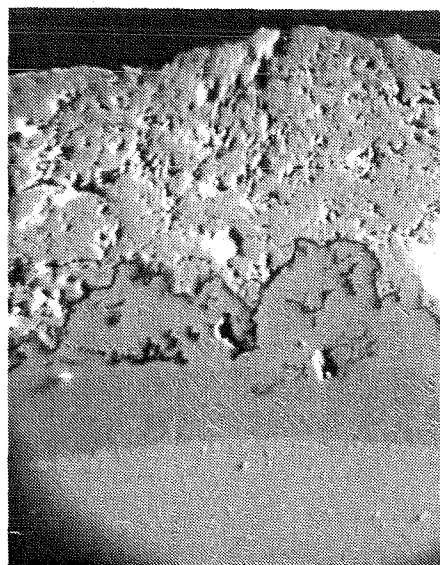
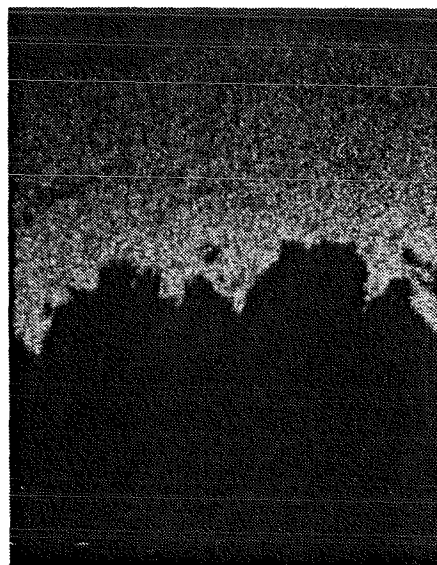
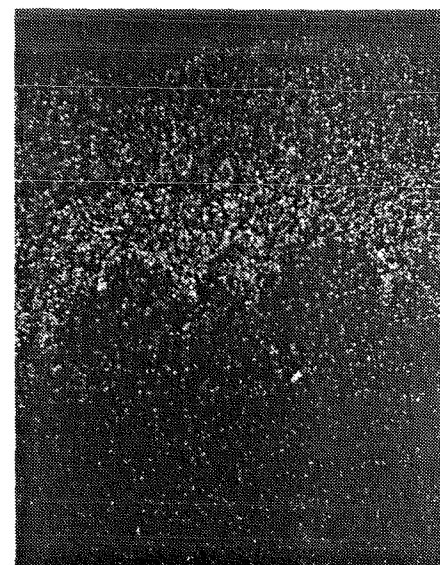
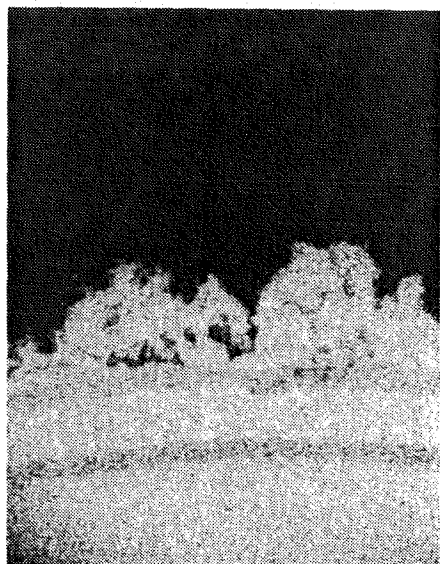
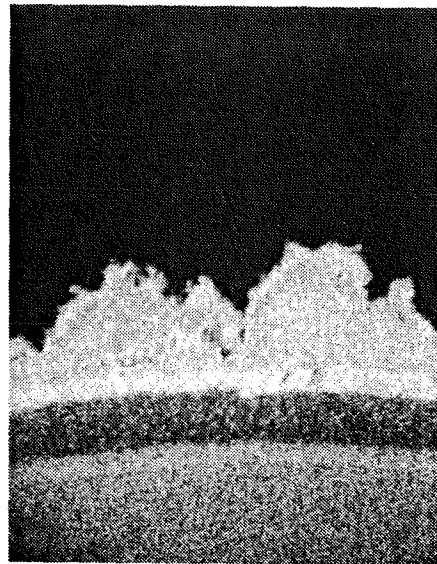
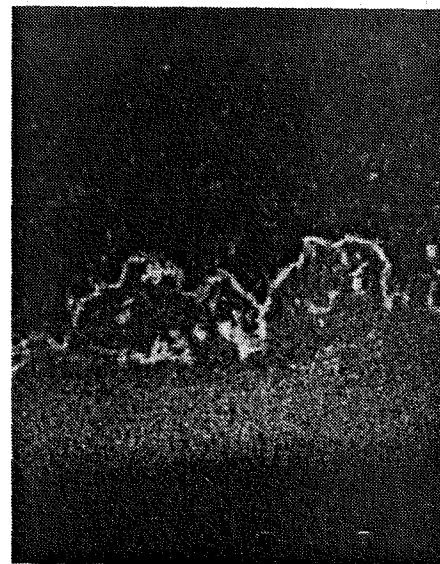
Figure 53. Secondary Electron Image and Elemental X-Ray Density Maps of Engine-Tested Stage 2 Blade (René 80) With Codep, Vacuum Plasma Sprayed Ni-22Cr-10Al-1Y and ZrO<sub>2</sub>-8% Without Y<sub>2</sub>O<sub>3</sub> Coatings - Leading Edge, Suction Side at 80% Span (Blade No. 42, Table XV).

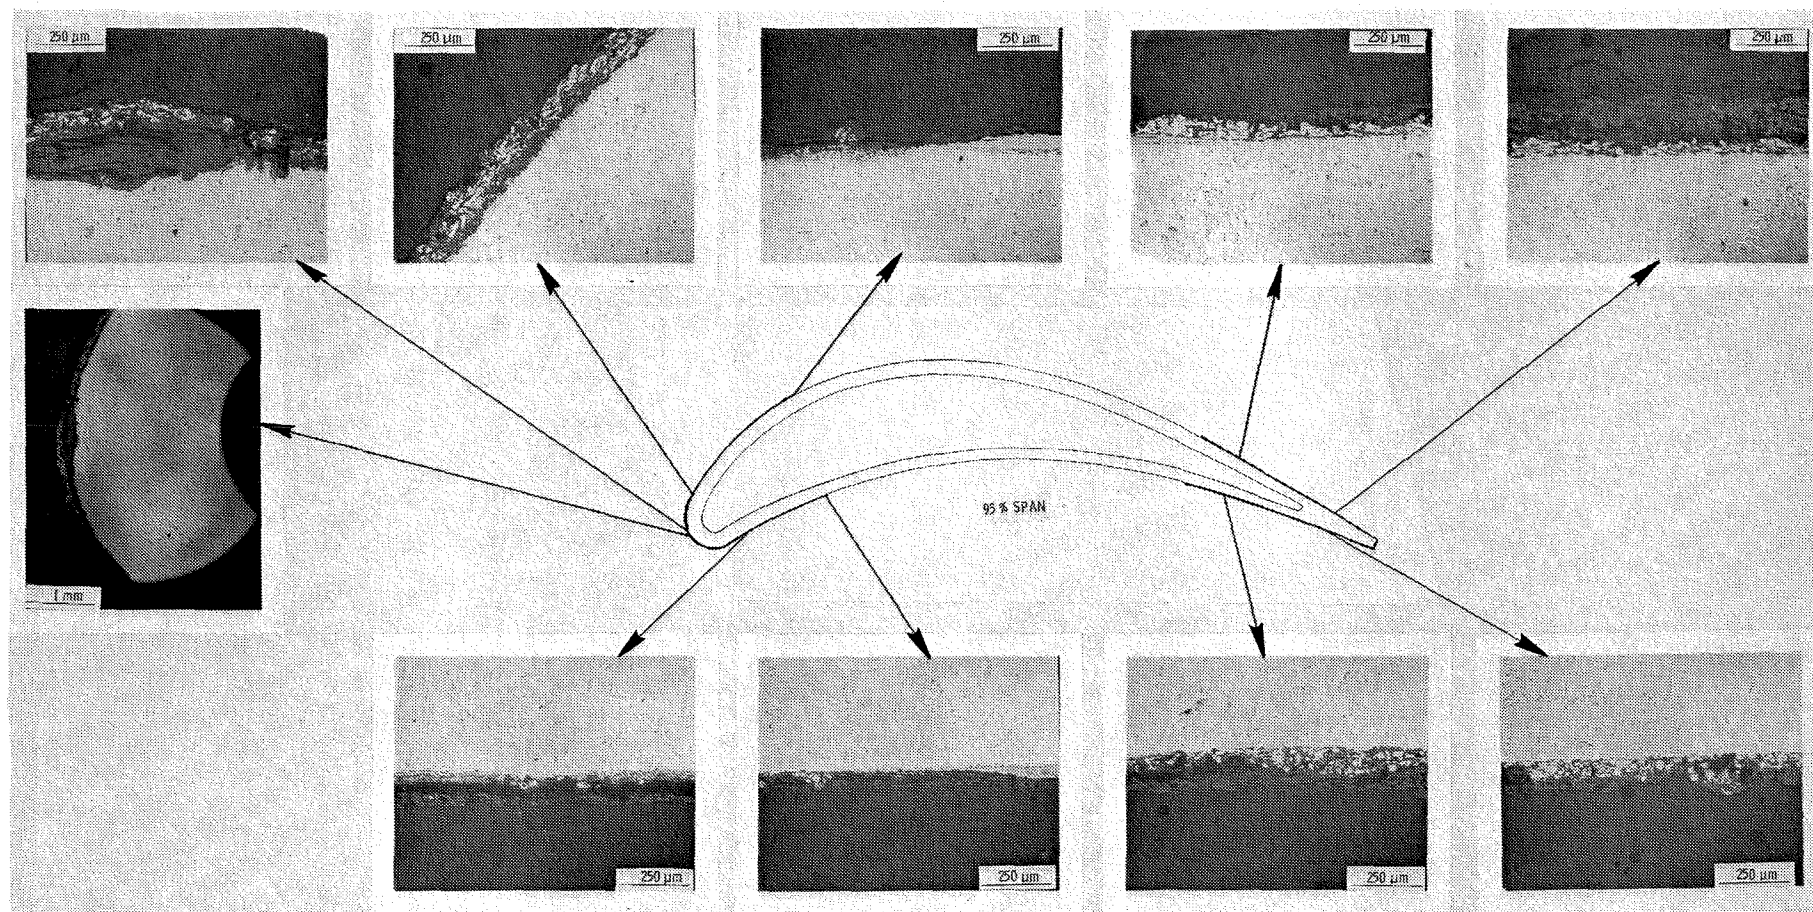
Two engine-tested Stage 2 vanes (paired), one with TBC and one without (Codep only), were sectioned at 15%, 50%, and 95% spans and in the outer and inner band regions for metallographic examination. Microstructural examination showed the Codep coating to be in good condition, whereas the thermal barrier coating was extensively damaged. It also showed that the Codep layer had been completely removed as planned by grit blasting in areas where the bond coat and ceramic top coat were applied by conventional plasma spraying. Figures 57a and 57b show the optical photomicrographs of a thermal-barrier-coated airfoil at 95% and 15% span cross sections, respectively. It can be observed that at 95% span, near the outer band, the TBC was severely damaged. The ceramic layer had spalled and local oxidation of the René 80 substrate had taken place at the leading edge; maximum penetration of René 80 in localized regions was 0.13 mm (0.005 in.). The TBC appeared to be in better condition at the trailing edge, but thinning of the ceramic layer was observed. It should be noted that the bond coat, wherever remaining on the airfoil surface, had provided adequate oxidation protection to the underlying substrate. The TBC appeared to be in much better condition at the 15% span, although thinning of the ceramic layer was observed on the suction as well as pressure side of the airfoil. The bond coat and top coat layers were not nearly as uniform in thickness on the Stage 2 vanes as they were on the blades. This is due to the difficulty in manually coating a complex shape such as a Stage 2 vane. Further improvements in the application of the coating, preferably by an automatic process, are needed to apply a quality coating. Improvement is also needed in the erosion resistance of the ceramic layer.

Figure 57a. Photomicrographs of Engine-Tested (1000 "C" Cycles), CF6-50, Stage 2 Vane With TBC (Ni-22Cr-10Al-1Y/ZrO<sub>2</sub>-20%Y<sub>2</sub>O<sub>3</sub> Duplex); 95% Span.

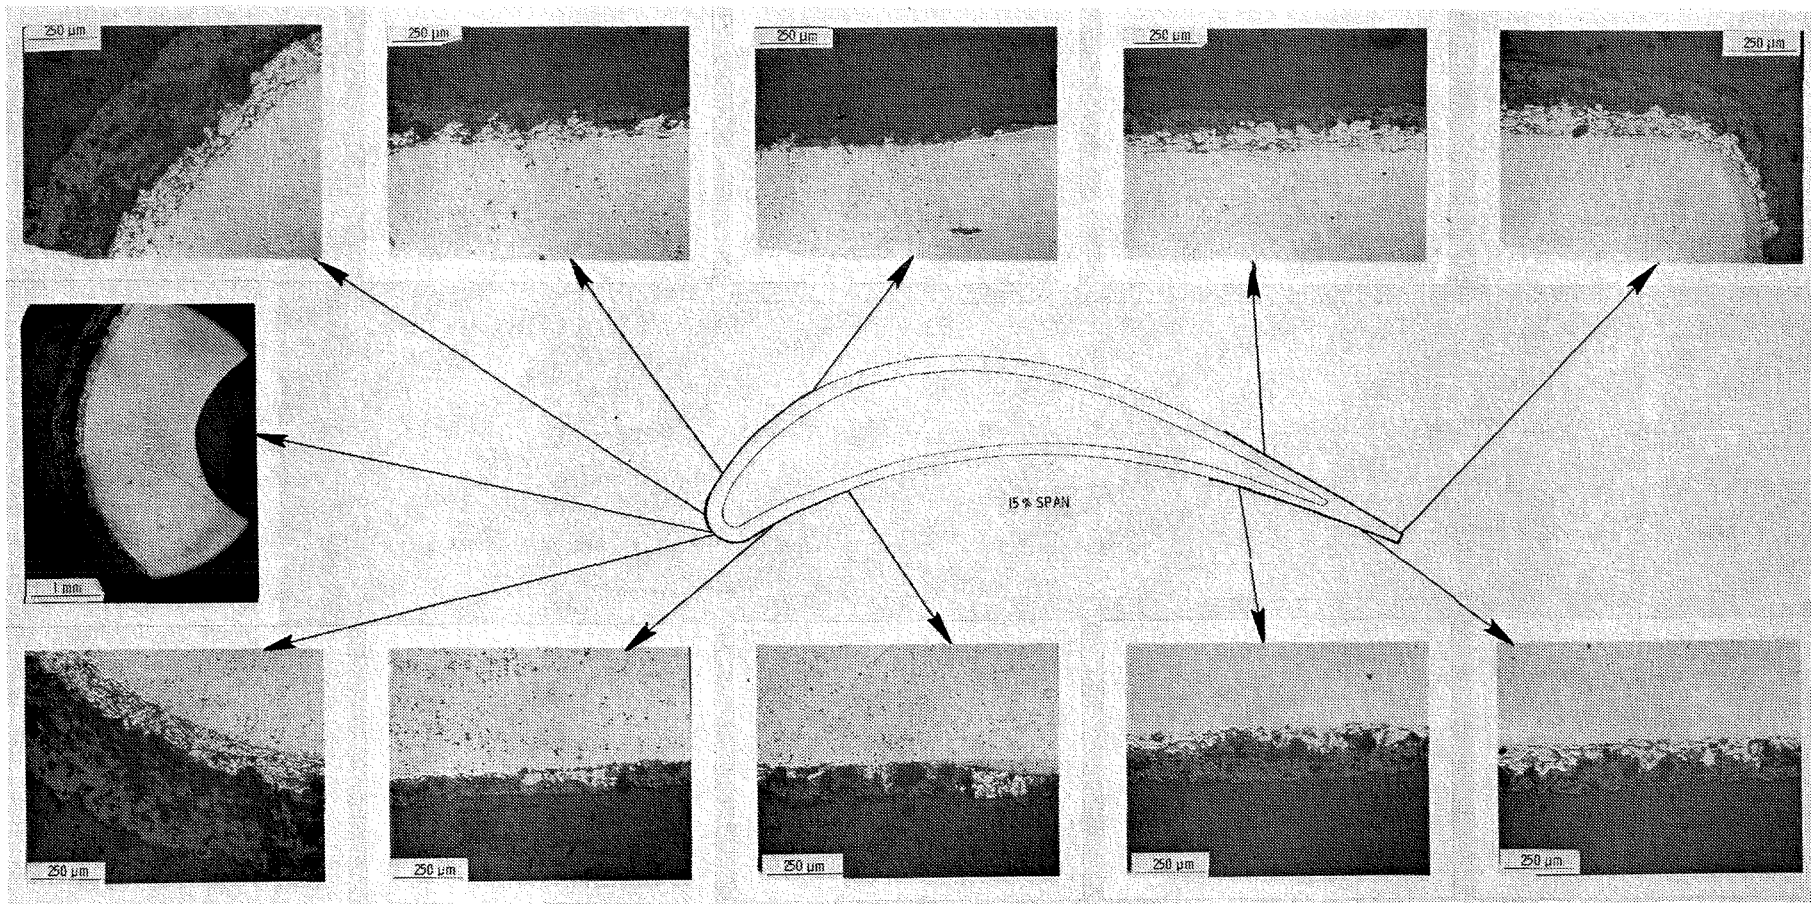
Figure 57b. Photomicrographs of Engine-Tested (1000 °C Cycles), CF6-50, Stage 2 Vane With TBC (Ni-22Cr-10Al-1Y/ZrO<sub>2</sub>-20%Y<sub>2</sub>O<sub>3</sub> Duplex); 15% Span.
